⑥ National Dam Inspection PROGRAM.
KNIGHT DAM, PERKIOMEN CREEK, Montgomery County,
PENNSYLVANIA.
(NDS I.D. NO. 00395,
DER I.D. NO. 46-257)
Number
←
PHASE I INSPECTION REPORT,

**PHASE I INSPECTION REPORT
NATIONAL DAM INSPECTION PROGRAM**

Name of Dam: Knight Dam
County Located: Montgomery County
State Located: Pennsylvania
Stream: Perkiomen Creek
Coordinates: Latitude 40° 20.0'
Longitude 75° 28.9'
Date of Inspection: November 19, 1979

PHASE I INSPECTION REPORT
NATIONAL DAM INSPECTION PROGRAM
KNIGHT DAM
NATIONAL ID NO. PA 00395
DER NO. 46-257

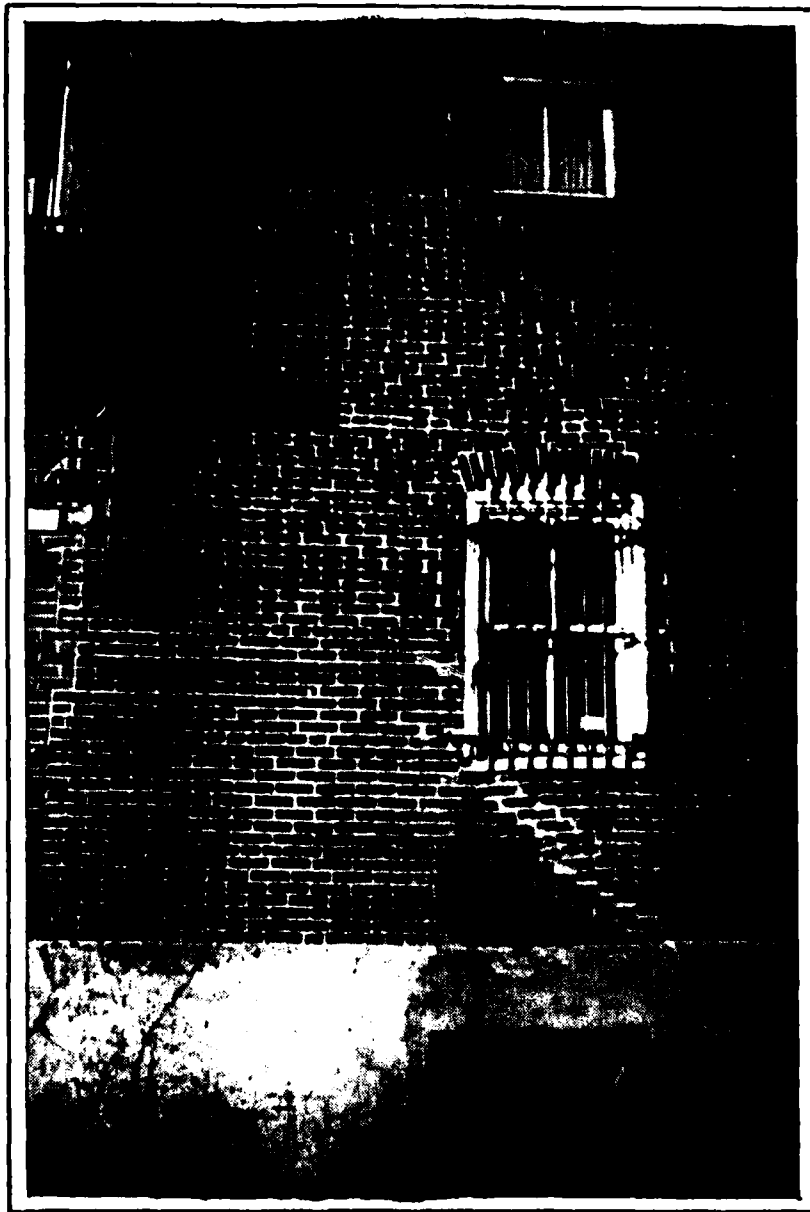
PHOTOGRAPH NO. 8

SMALL PART OF PERKIOMEN
CREEK FLOW IS DIVERTED
THROUGH THE BASEMENT OF
THIS BUILDING.
